1. Exponent was retained by counsel for Tyco Fire Products, LP, to conduct an investigation of the rupture of the fire suppression test tank that occurred on February 12, 2016, at Oprandy's Fire and Safety Equipment, Inc., in Middletown, New York.

**EXPERT REPORT OF ERIK  
W. CHRISTIANSEN**

**Buono v Poseidon Air Systems  
et al.:  
Engineering Investigation of a  
Ruptured Fire Suppression  
Test Tank Cylinder**

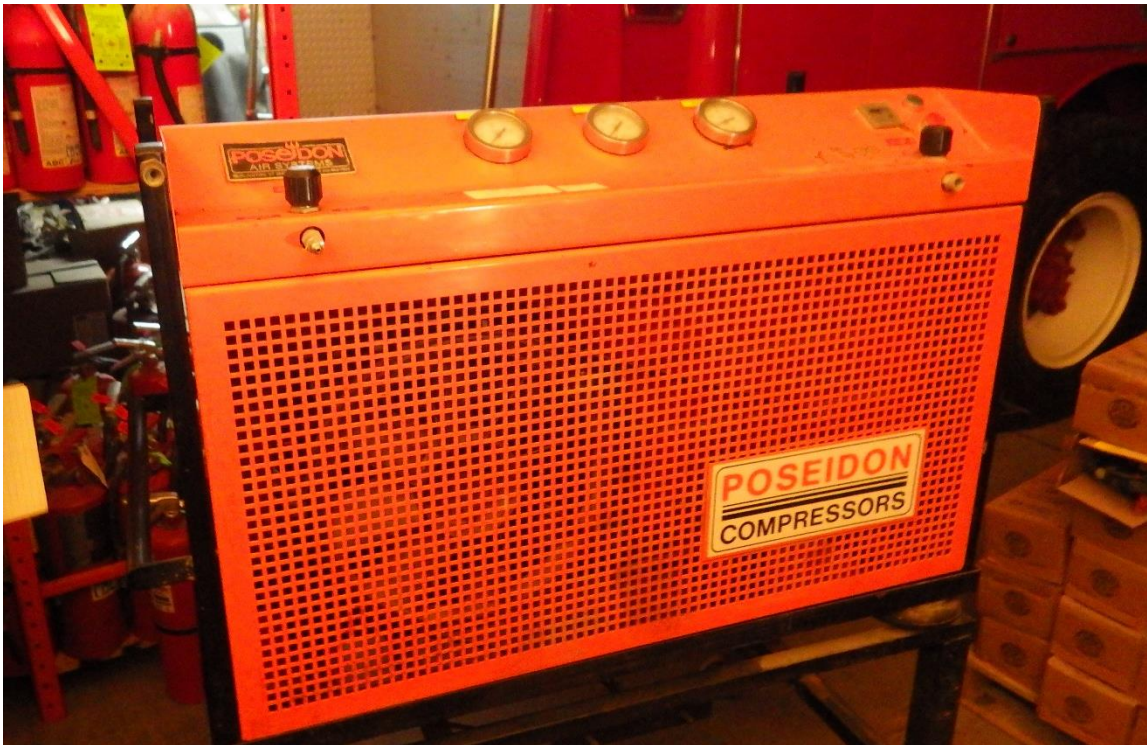
Figure 3. Poseidon air compressor on August 14, 2018.

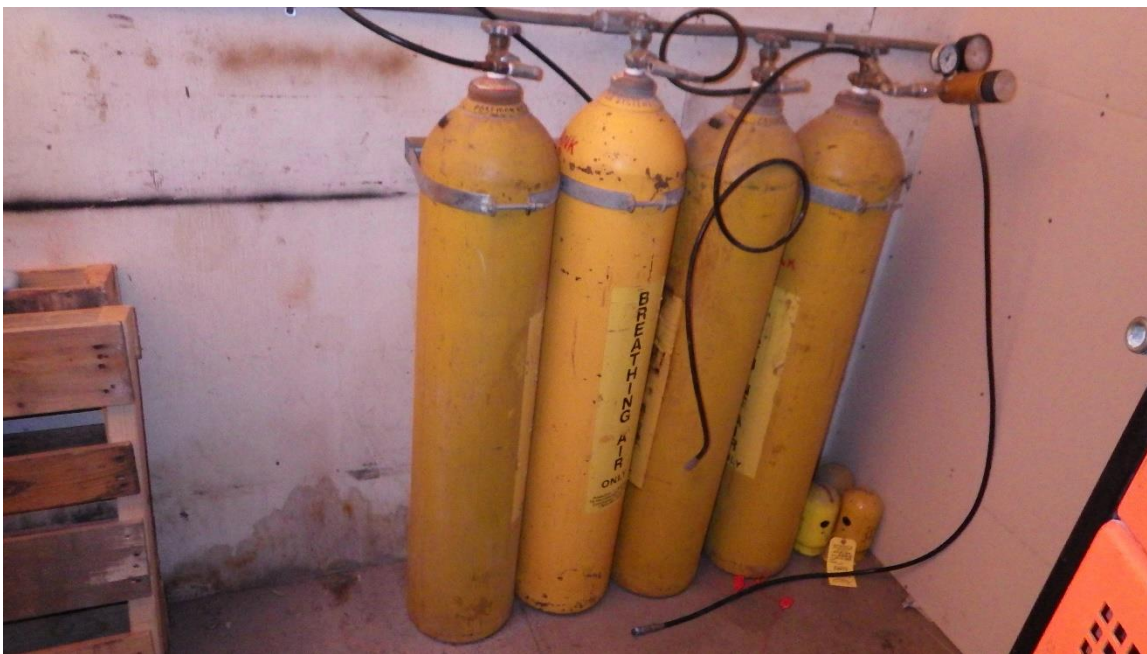
Figure 4. Photograph of Poseidon cascade system on August 14, 2018.

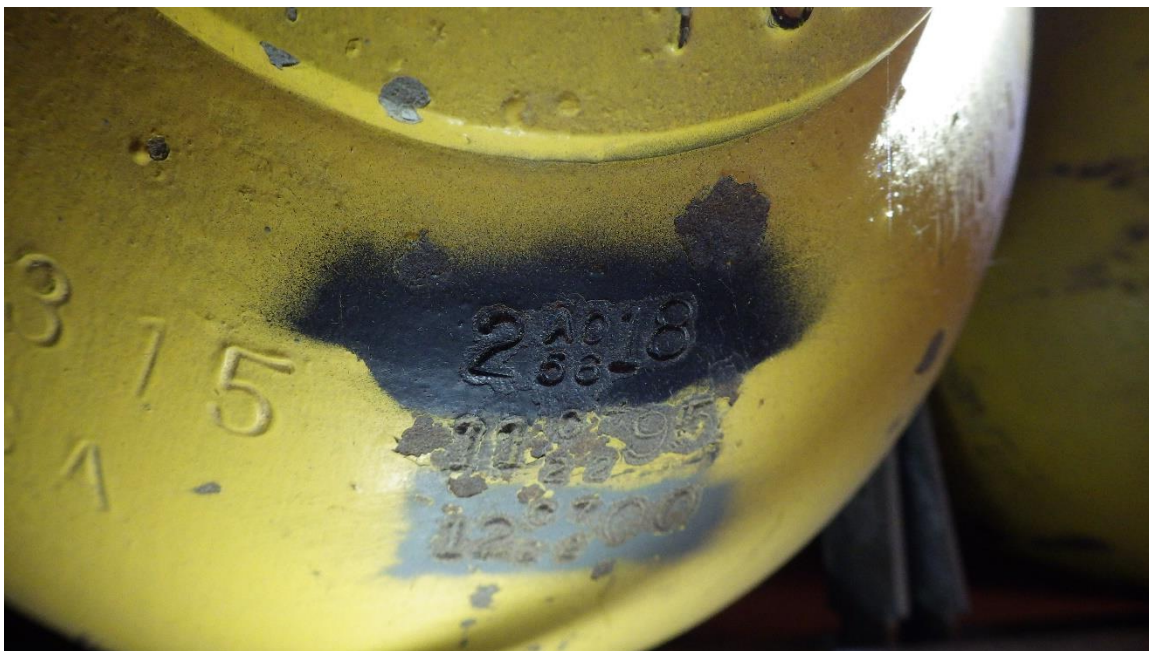
During inspection of the cascade system high pressure gas cylinders, it became apparent that the cylinders had been hydrostatically tested since the incident occurred. Figure 5 shows the markings "2 <sup>AO</sup>/<sub>56</sub> 18" stamped onto the side of one of the Poseidon cylinders. This indicates the cylinder was hydrostatically tested in February 2018, as certified by facility or inspector identified as "AO56." All four incident cascade cylinders had identical stamps. Hydrostatic testing is a common procedure for pressurized components, in which liquid (such as water) is used to bring the unit to a specified pressure in a safe manner. Therefore, the compressed air pressure in the bottles on the day of the incident must have been released after the incident to perform the hydrostatic test. This precluded Exponent from determining the pressure in the high-pressure gas cylinders.

Figure 5. Hydrostatic test date stamp on cascade system bottles.

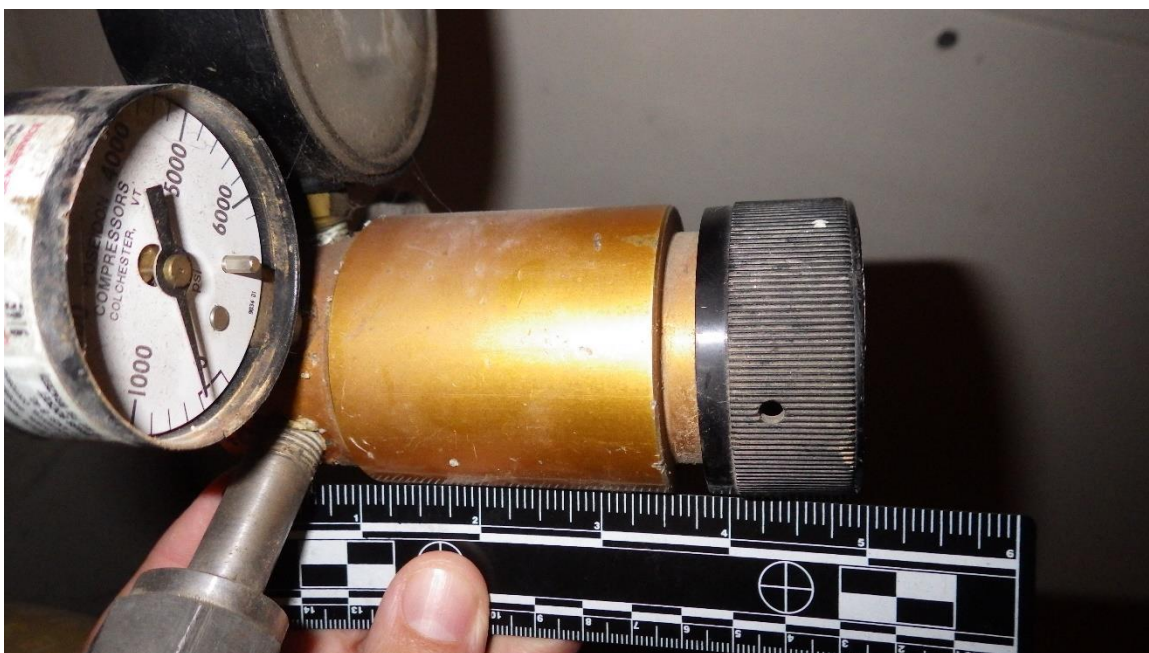
The manually adjustable incident pressure regulator seen in Figure 6 was inspected, and it was observed that the gauge which indicates the regulator inlet pressure was missing a faceplate. The needle on the outlet pressure gauge was broken as well. The incident regulator had no label that would identify the manufacturer or specifications; the only marking found was the number "59" stamped on the back. The engagement (or "travel length") of the adjustment knob relative to the lip on the regulator body was measured to be 0.255-0.280 inches. The adjustment knob is

attached to an adjustment screw which controls the regulator outlet pressure. The position of the adjustment knob thus provides information on what pressure may have been delivered to the incident cylinder.

Figure 6. Photograph of incident pressure regulator on August 14, 2018.

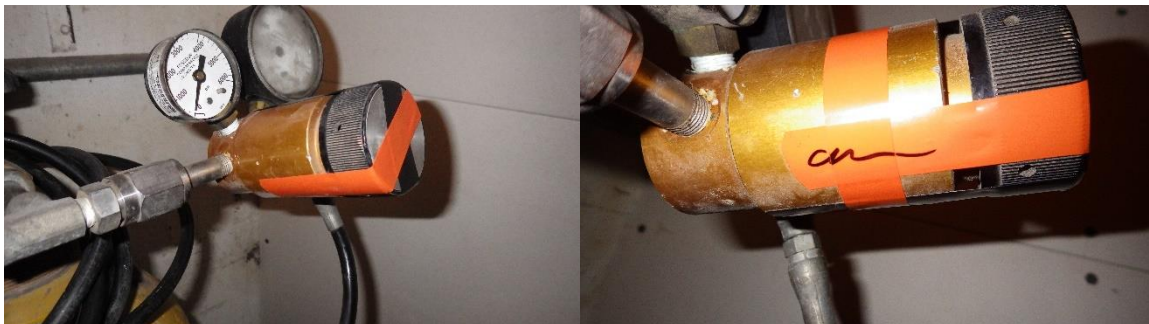
To preserve the position of the pressure regulator adjustment knob, several pieces of tape were placed across the face of the knob, extending down to the regulator body, as seen in Figure 7. A second pressure-reducing regulator (known forward as the “exemplar regulator”), similar in appearance to the incident regulator, was located at Oprandy’s. The exemplar regulator was manufactured by Aqua Environment, model 415-5000, whose specifications indicate a design for up to 6,000 psi inlet pressure and 0-5,000 psi outlet pressure. The incident regulator, incident valves and lines, and incident cascade cylinders were collected on May 9, 2019 as evidence for off-site examination and testing. On the day of evidence collection, the incident cascade cylinders and incident regulator were found to have been moved to the middle of the shop floor at Oprandy’s. In addition, Oprandy’s refused to allow parties to remove the Poseidon air compressor to determine the maximum outlet pressure it could generate. They also declined to provide the exemplar regulator at that time, although it was made available for subsequent testing.

Figure 7. Photograph of incident regulator tape and signature.
